COAST GUARD RESEARCH AND DEVELOPMENT CENTER GROTON CT F/6 13/12
CHIEF PETTY OFFICER (CPO) BERTHING COMPARTMENT BURNOUT TESTS.(U)
MAR 80 C D WOLVERTON
CGR/DC-16/79

1. Report No. USCG D-78-79	2. Government Accession No.	3. Recipient's Catalog No.
4. Title and Subtitle CPD BERTHING COMPARTMENT BURNOUT TESTS	5. Report Date MARCH 1980	6. Performing Organization Code

16. Abstract This series of six tests evaluated performance of three types of lightweight non-structural bulkhead panels when subjected to berthing compartment fire conditions. The tests were conducted in full-scale compartments constructed aboard the test vessel ALBERT E. WATTS at the U.S. Coast Guard Fire and Safety Test Detachment, Mobile, Alabama. Each test compartment simulated a typical Coast Guard cutter 2-man chief petty officer berthing compartment arrangement, including standard shipboard furniture (bunks, clothing lockers, bookrack and chair). A realistic fuel load was provided, including clothing, publications, and standard issue mattresses and bedding. Fuel load arrangement, test compartment ventilation, method of ignition and test duration (60 minutes) were similar in all cases. Maximum recorded temperatures

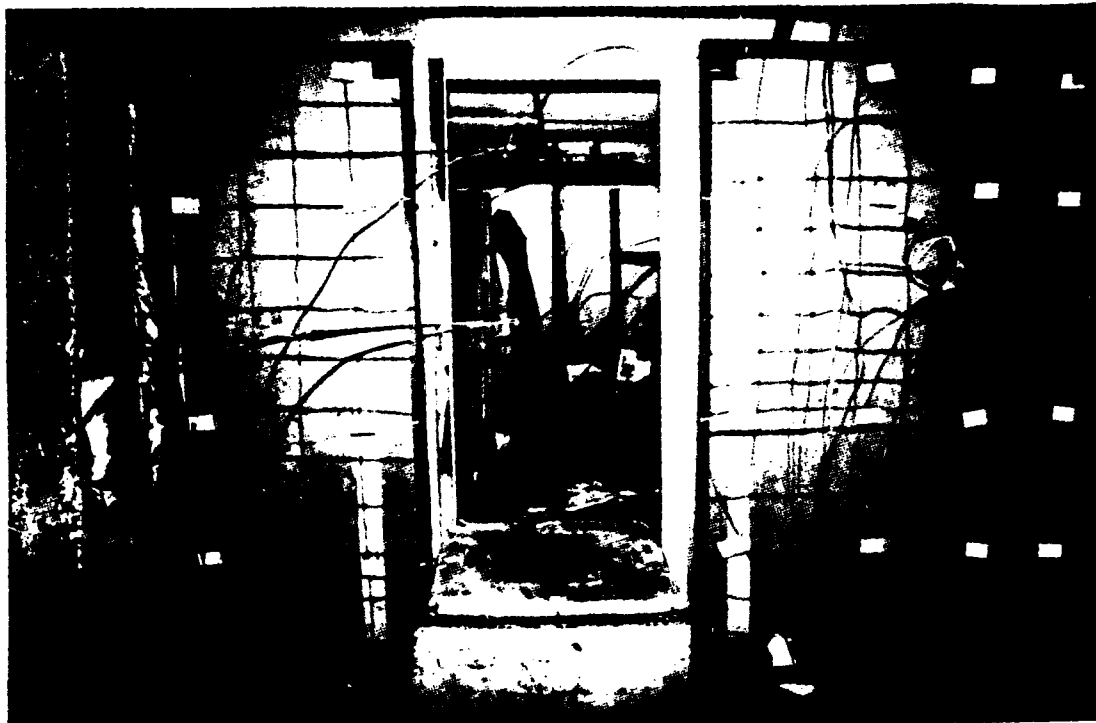
FIGURE 5

TYPICAL TEST COMPARTMENT EXTERIOR

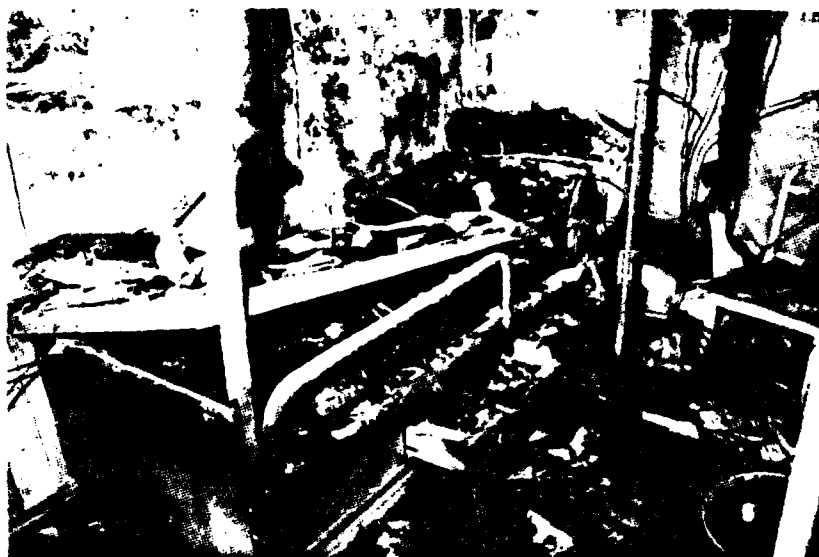
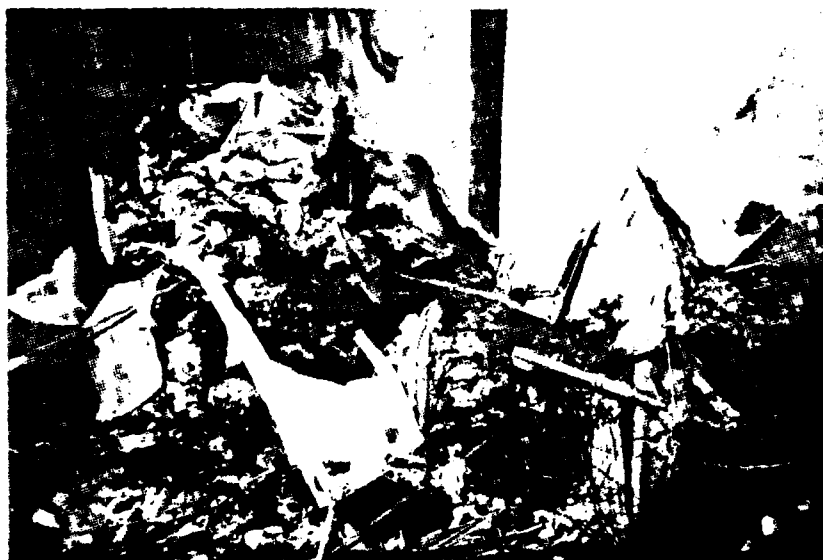
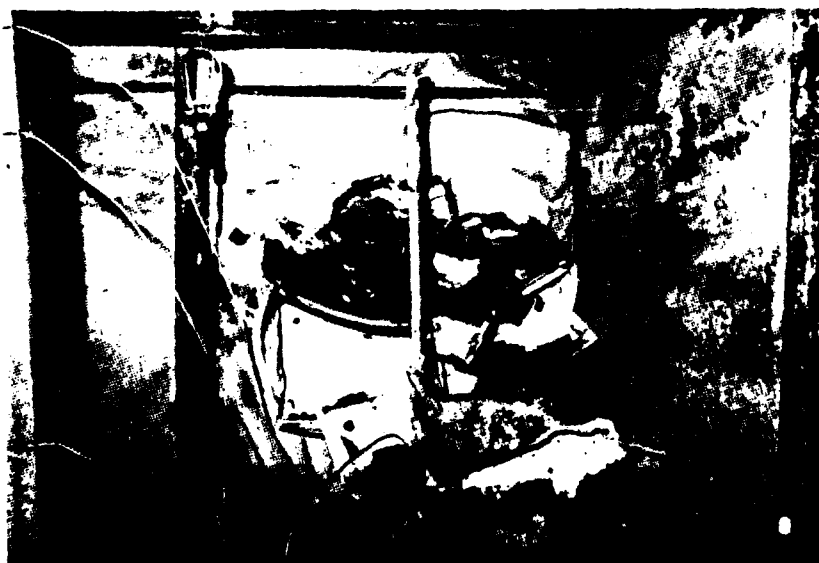
FIGURE 12
TYPICAL CONDITION OF FURNITURE AFTER FIRE

The double bunk unit, lockers, and bookrack were severely damaged during each test, except for Test 1. That test was the only one in which the bunk unit and the bookrack remained relatively intact.

Except for Tests 1 and 4, the upper bunk pan melted and allowed the steel spring assembly to drop onto the lower bunk. In the remaining tests, large portions of the headboard also were destroyed. Most of the paint on the lower bunk was still visible in all cases. In all tests, the tops of the lockers were destroyed. In Tests 1 and 5, about 75 percent of the doors and sides of the three lockers remained standing. In the remaining tests, the lockers were nearly completely destroyed except for the drawer area at the bottom. Bookrack damage increased progressively. In Test 1, the bookrack remained intact, with its paint burned off exposed areas. In following tests, the amount of damage increased, with the most severe amount occurring in Tests 4 and 6. In these the bookrack remained attached to the bulkhead panel, but was tilted forward with the shelves bent downward 6 to 8 inches at the center. In all tests, the rear of the bookrack remained bolted to the bulkhead panel. Figure 12 shows the typical appearance of the furniture after the test fires.

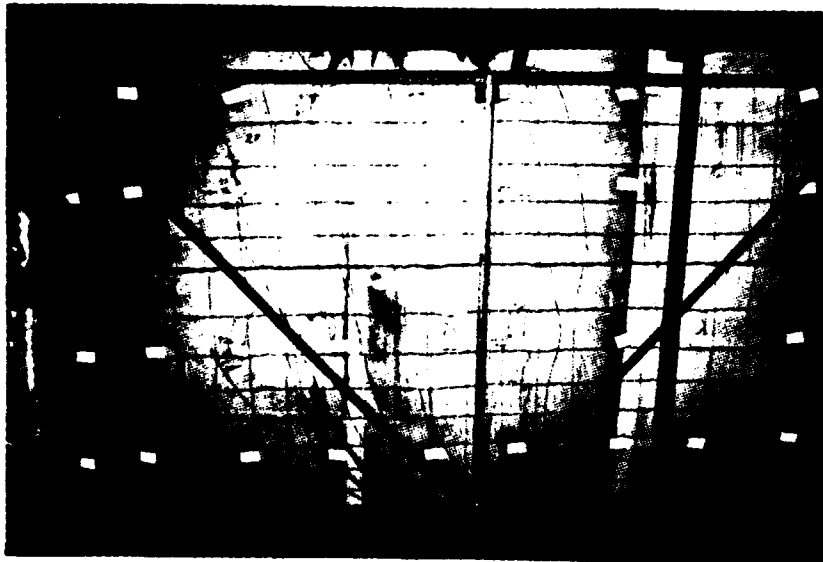
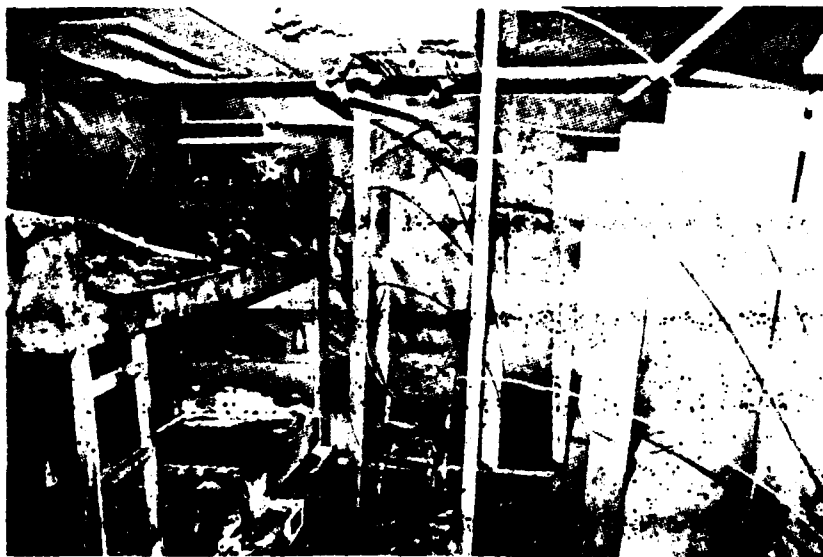
As shown in Figure 13b, large blisters with irregular outlines formed on the panel surfaces facing the fire. These blisters ranged from 6 inches to 2 feet in diameter by 1/2-inch high and were probably caused by outgassing from the core material and adhesives. Facing laminations were separated in the blistered areas.

In Test 4, two fiberglass H-posts were used in the bulkhead facing the instrumentation compartment. The objective was to determine whether a nonmetal joiner system would closely match the thermal expansion of the nonmetal faced panels and reduce the tendency of the panels to separate from the joiner system during a fire. Approximately 35 minutes into the test, this bulkhead gave way and the upper portions of panels E and F folded over into the test compartment. This occurred because of inadequate support of the joiner system. The fiberglass H-posts were not securely attached to the curtain plate and coaming plate. The upper Z-bars also warped in areas where there was a wide spacing between screws attaching them to the curtain plate. As the panels distorted due to heat, they eventually came free of the Z-bar and the weight of the bookrack attached to panel D caused the bulkhead to lean into the test compartment. Panel D remained clamped in corner post C/D/M and prevented complete collapse of the bulkhead. Figure 13c shows the appearance of this bulkhead after the test.

(a) Exterior surface of panels F, E and D after Test 1

(b) Blisters on interior surface of panel H after Test 1

(c) Exterior view of panels D, E and F after Test 4

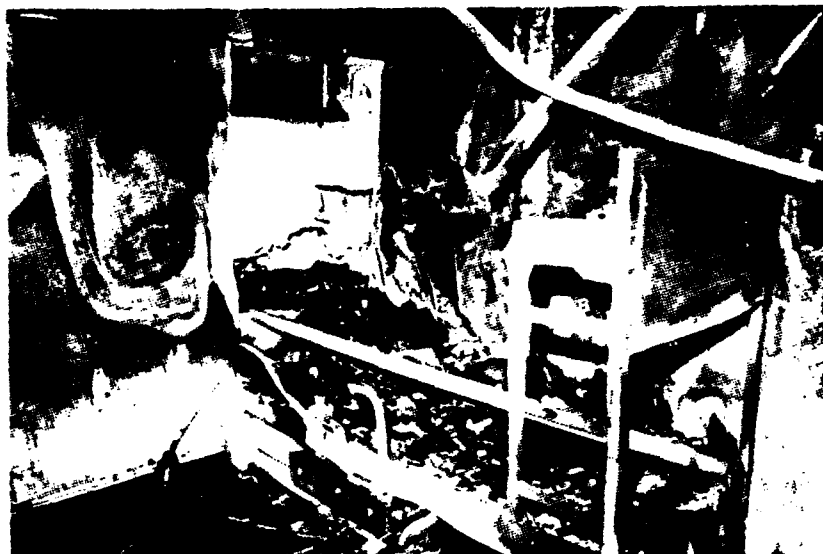
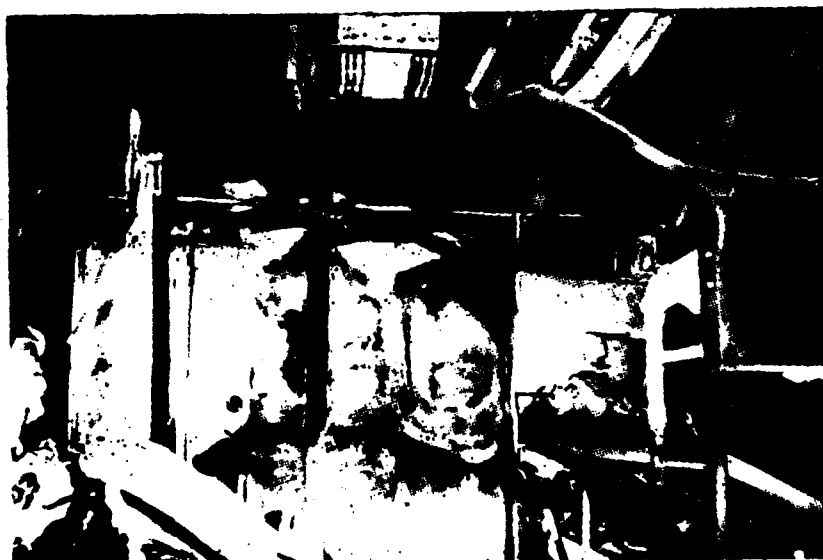
FIGURE 14

Overall, the steel-faced panels in Tests 2 and 6 showed less tendency to bow away from the fire than did the nonmetal-faced panels. The greatest amount of bowing observed was 1/2 to 3/4-inch. Following the fires, the galvanized coating inside the test compartments was found to be burned off the upper part of the panels, starting about 2 feet above the deck, as shown in Figure 14. The interior steel facing showed much severe wrinkling. Exterior surfaces remained generally wrinkle-free and retained most of their galvanized coating. See Figure 15.

In all areas, there was a more complete separation of the facing sheets from the core material than was observed with the nonmetal-faced panels. The galvanized steel interior facings tended to bulge into the compartment over much of the upper portions of the panels. These panels however, showed no greater tendency to separate from their tracking system than did the nonmetal-faced panels, even after the panel facings were pushed in and out several times by hand and the charred core material had been largely crushed and separated from the facing sheets.

(a) Bulges and wrinkles on interior panel facings near bunks after Test 2

(b) Wrinkled facing on panel H after Test 2

(c) Bowed H-Post L/K after Test 6

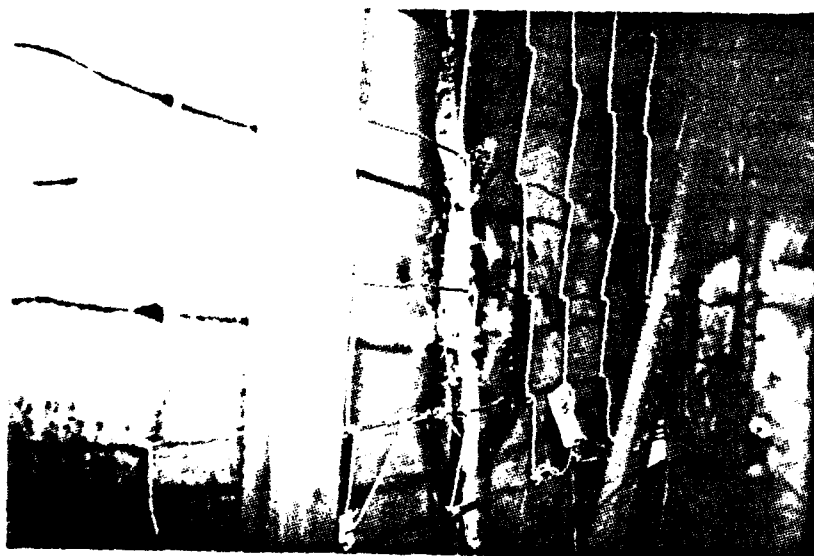
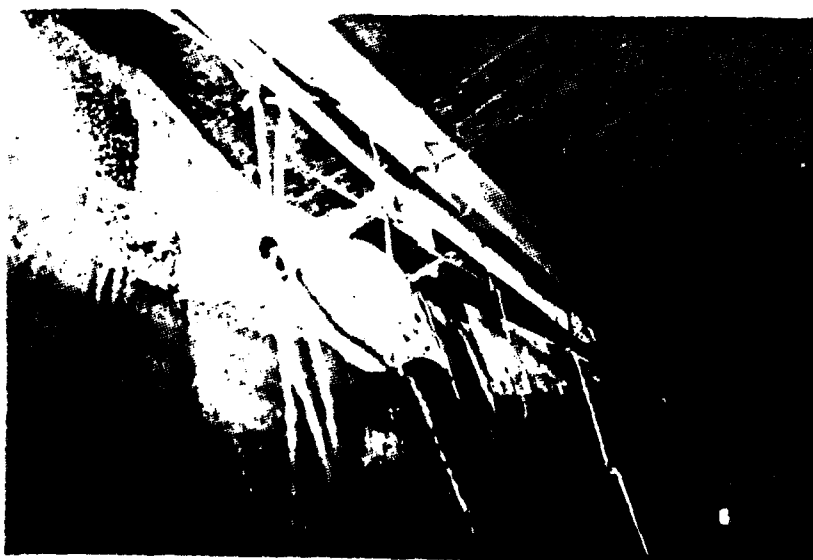
In Test 2, several patches of soot 2 or 3 inches in diameter on exterior surfaces adjacent to H-posts showed that smoke had passed through the bulkheads. The panels were not distorted in these areas and appeared to be tight against the H-posts. A significant breach was observed in Test 2 at H-post E/F (located adjacent to the bunks). Starting at about 30 inches above the deck, the H-post was badly distorted. The H-post and adjacent portions of panels E and F showed a wave-shaped distortion, bending into and out of the test compartment a total of three times between 30 and 60 inches above the deck. Gaps of about 1/2-inch occurred between the H-post flanges and the panel facings. See Figures 15a and 15b.

In Test 6, a large breach occurred along nearly the entire length of the instrumentation compartment bulkhead, at the top of panels D, E, and F. This area is shown in Figure 15c. Prior to the test, it was noted that the curtain plate was somewhat distorted in this area, and that the in-board edge of panel E was not inserted into H-post D/E for a distance of 15 inches down from the top. The curtain plate Z-bar along this bulkhead was welded to the curtain plate at intervals of 15 to 18 inches to improve support conditions for the bulkhead panels in an attempt to compensate for the improper installation. About 30 minutes into the test, the upper portion of the bulkhead began to separate from the curtain plate. The upper ends of H-posts D/E and E/F were pulled free of the curtain plate, and the bulkhead as a unit leaned into the test compartment, creating an irregular breach up to 8 inches wide. The weight of the bookrack attached to panel D helped cause the bulkhead to lean. The upper half of panel D was pulled free from corner post C/D/M.

(a) Panels D, E and F
after Test 2

(b) H-Post E/F after
Test 2

(c) Panels D and E
after Test 6

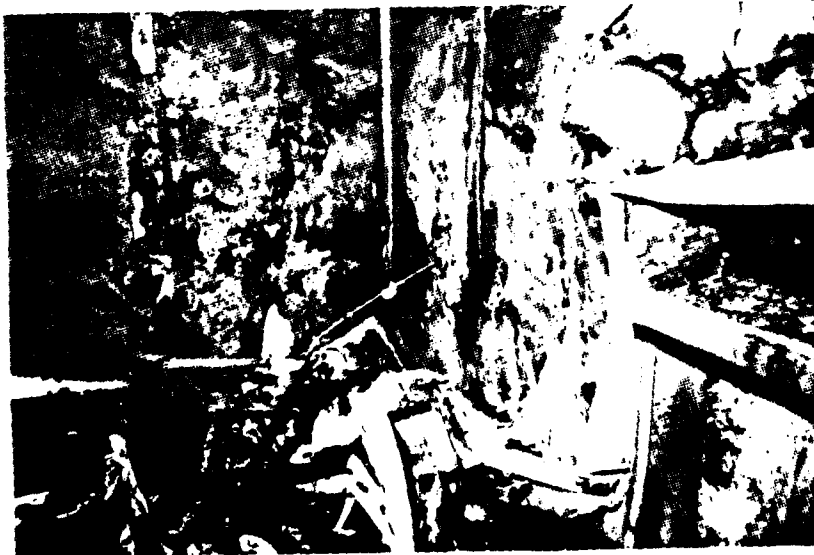
FIGURE 16
PAINTED STEEL-FACED PANELS AFTER FIRE (INTERIOR)

Compared with the galvanized panels, slightly less wrinkling occurred on the interior facing sheets, which were thicker material on the painted panels. Overall bulging of the panels appeared to be slightly less than was observed with the galvanized panels. See Figure 16. About the same number of small sooted areas on exterior surfaces were noted adjacent to H-posts as in Tests 2 and 6, indicating areas where small amounts of smoke had passed through the bulkhead. No major breach occurred in either test. On interior surfaces, the paint was almost entirely burned off most of the panels. On the instrumentation compartment bulkhead exterior surfaces, paint was burned off a large area opposite the bunks (Test 3; see Figure 17a) or lockers (Test 5). Paint on the passageway bulkhead was burned off the upper 3 feet of the panels, as shown in Figure 17b. The remainder of the paint on both bulkheads was not scorched or blistered.

(a) Panels near bunks,
showing bowed H-post
E/F after Test 3

(b) Wrinkled facing on
panel D
after Test 5

(c) Bowed H-post J/K
after Test 3

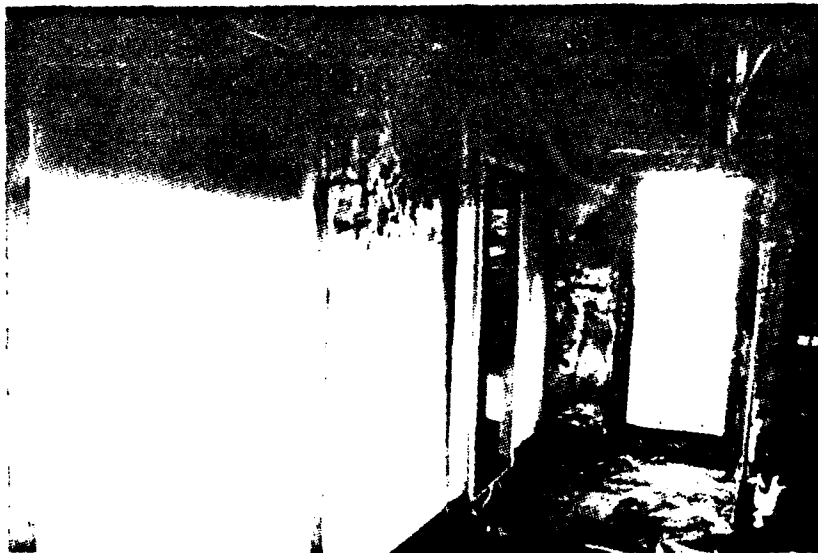
FIGURE 17

(a) Exterior surface of panels F, E and D after Test 3

(b) Exterior surface of panels M and C after Test 3
